NASA TN D-5654

# APOLLO COMMAND MODULE MOCKUP FLAMMABILITY TESTS

*Manned Spacecraft Center  
Houston, Texas*

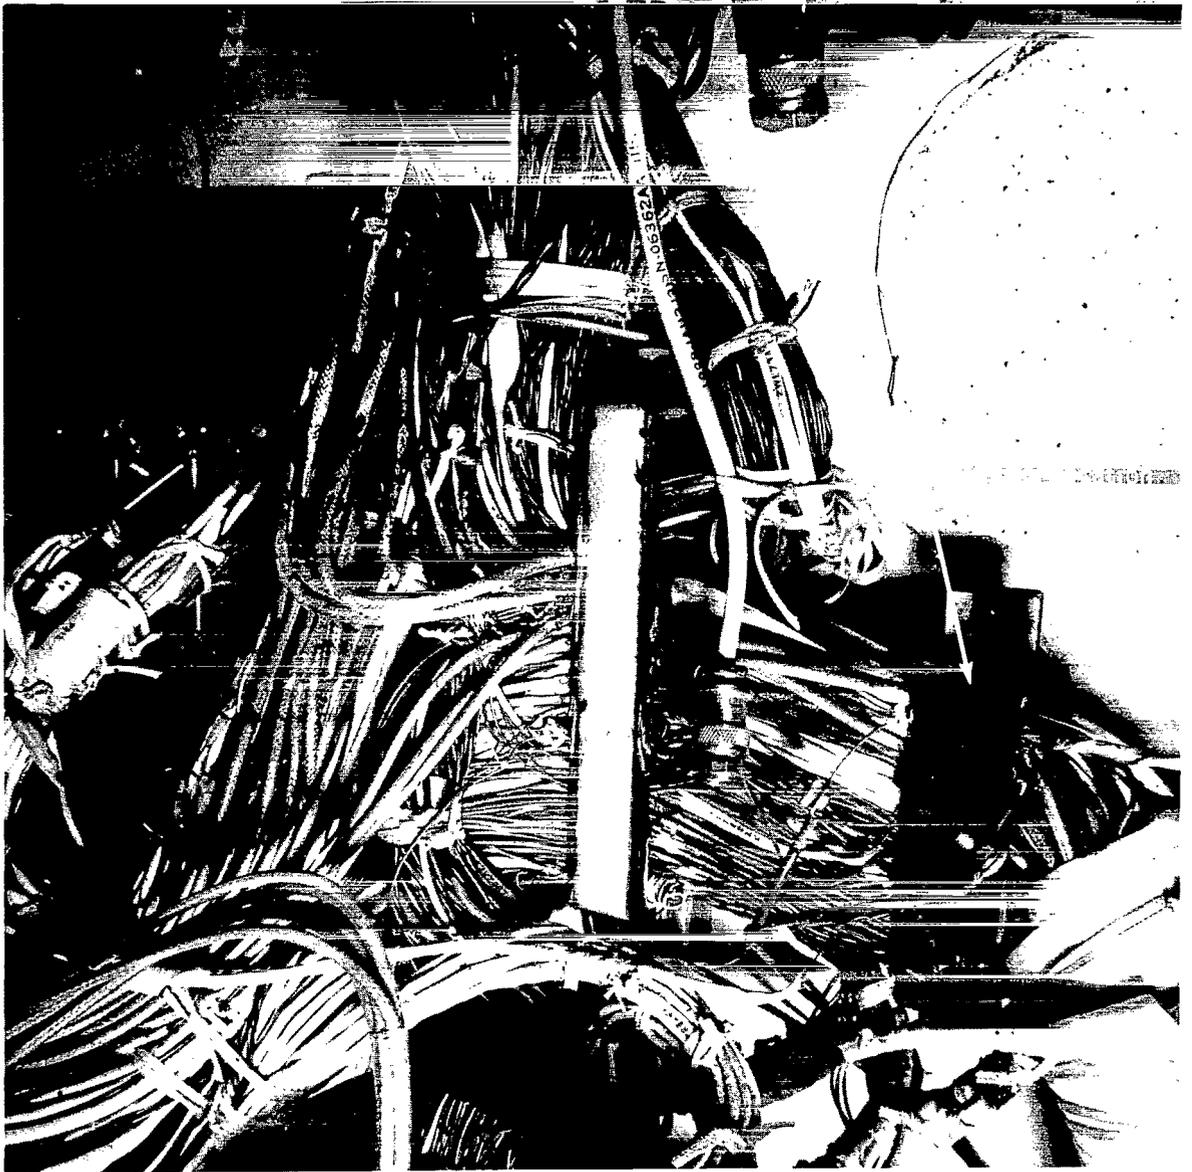
Figure 23. - Post-test damage (test 135).

In test 135, the coaxial cable ignited and burned from the point of ignition to a point approximately 18 inches away, where the fire self-extinguished. In similar tests (tests 119, 128, and 134), ignition was initiated on a saddle clamp which held, in addition to electrical wire, a small bundle of coaxial cables. In these tests, the coaxial cable did not ignite. A significant result of test 135 was that no smoke was evident in the cabin even at the conclusion of the 16-minute test. The burning polyolefin produced much dripping of flaming particles, and adjacent wires were damaged because of the loss of Teflon insulation. The slight amount of smoke resulting from the fire was significant from the standpoint of detection. In the unsuited condition, the crew would smell the products of combustion even though no smoke would be seen; and, therefore, the crew could take the required action. However, with the crew suited and with the closed-loop suit circuits in operation, the products of combustion would not be detected by odor. Therefore, no adequate means would exist for early detection by the crew of a coaxial-cable fire. Although the coaxial cable does not carry sufficient power to constitute a primary ignition source, it is located near wires that do carry sufficient current.

in vertical runs of the cable. During the testing at 6.2 psia, there were five ignitions in close proximity to the coaxial cable. In one test, the coaxial cable ignited and burned from the point of ignition to a point approximately 18 inches away, where it self-extinguished. In the other four tests, flames did not propagate along the intended ignition path from the igniter to the cable.

Corrective action — Because additional component testing indicated that the coaxial cable would present a flammability problem, especially at higher oxygen contents, it was decided to wrap all accessible portions of the coaxial cable with aluminum tape before any additional tests were run. Aluminum tape was observed not to prevent propagation in test 319; however, tests 119 and 219 indicated that the tape would be effective at the lower pressure of 6.2 psia or in a 60-percent-oxygen/40-percent-nitrogen atmosphere.

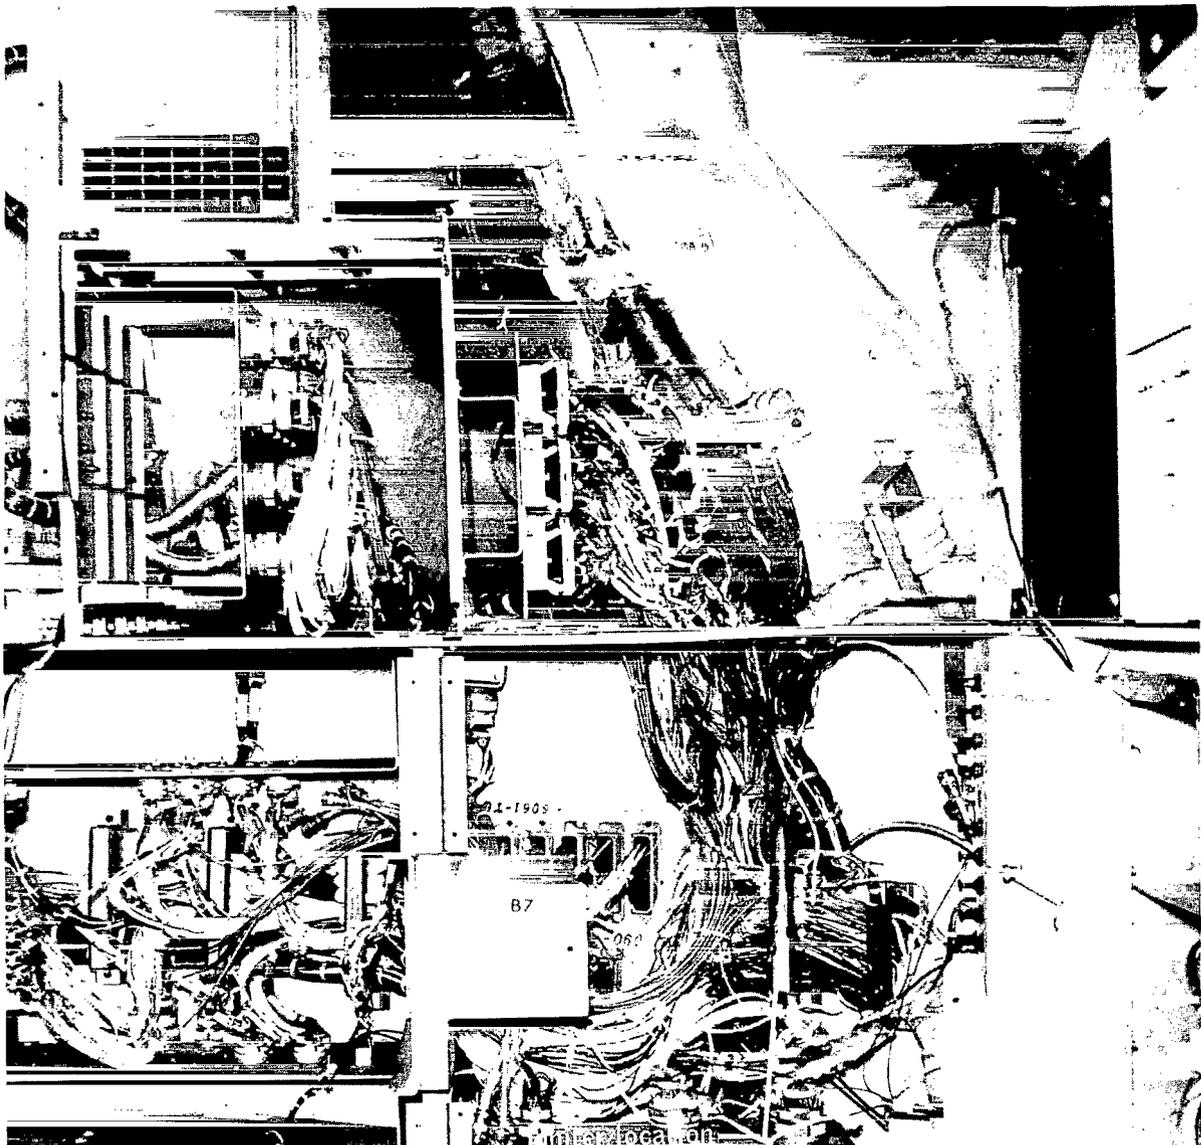
Figure 34. - Post-test damage (test 219).

In test 219, the coaxial cable ignited, and an area extending approximately 48 inches above the ignition location burned before the test was terminated. The fire and heat resulting from this test produced considerable damage to adjacent wire bundles. A significant result was that smoke was not produced in visible quantities until after the fire had become fairly large. In this environment, the crew would be suited; therefore, the products of combustion would not be detected by odor, and the fire probably would not be detected until smoke was observed in the cabin.

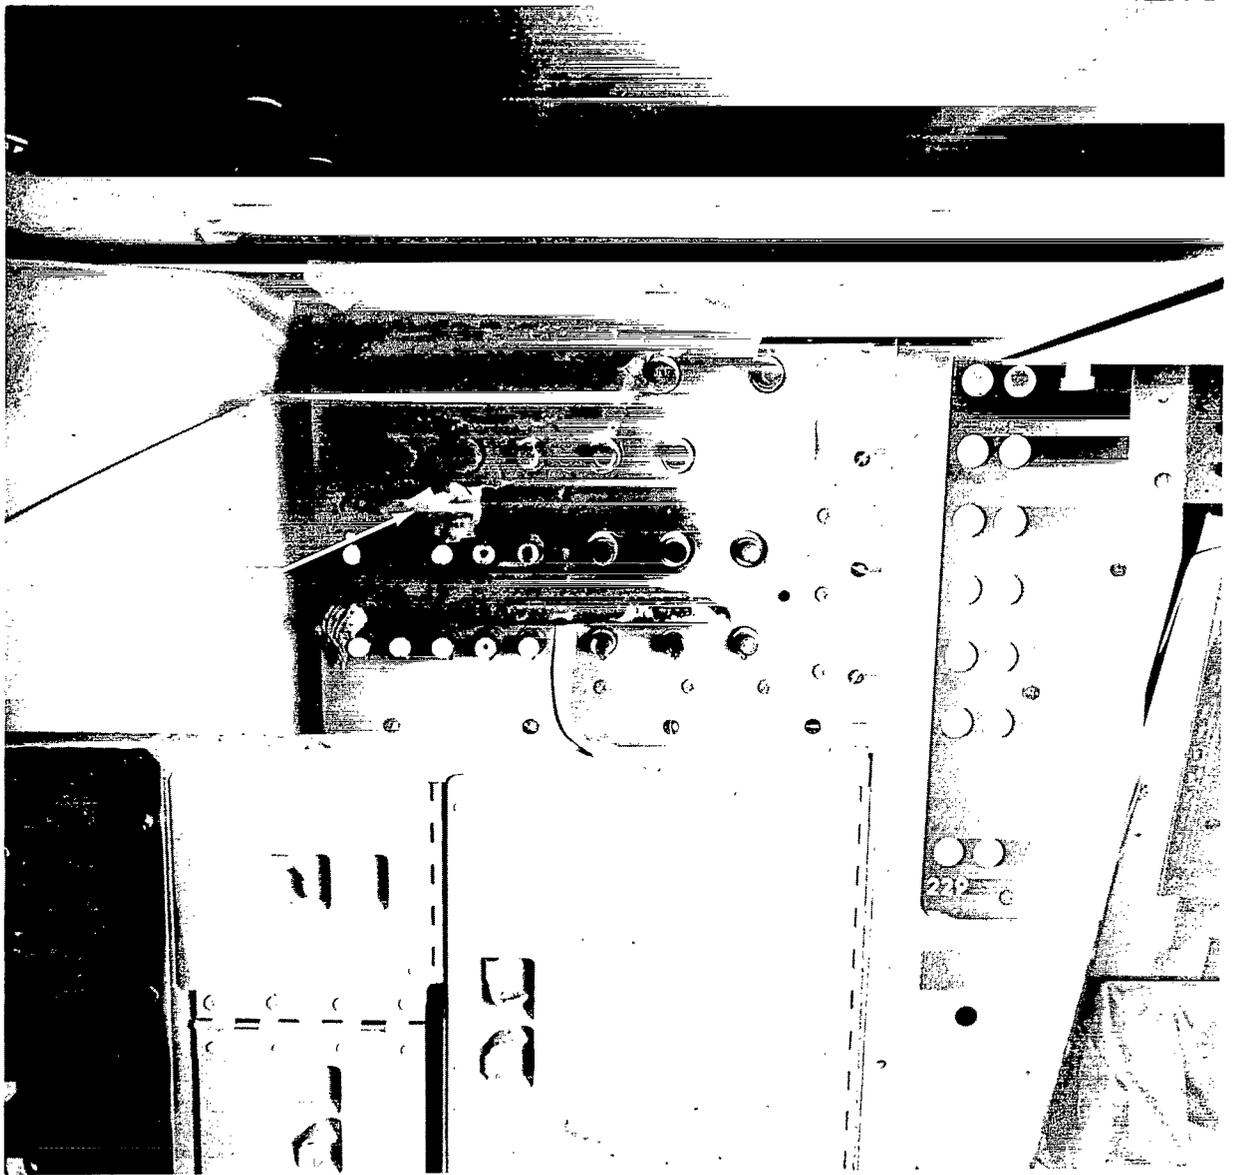
A pronounced increase in damage was noted in test 302 (meter in panel 2), test 303 (switch in panel 2), test 306 (CB in panel 225), test 312 (silicone-laminate cover on panel 8), test 326 (wire bundle leading to ground-support-equipment (GSE) window), and test 330 (Teflon wrap on wire bundle exiting from forward end of RH floor tray).

Circuit-breaker panel (16.2 psia 100 percent oxygen). - The igniter was located under the conformal coating. A 0.090-inch thickness of Ladicote was applied over the conformal coating. Light smoke was observed 38 seconds after ignition. Heavy smoke was observed at T + 2 minutes 20 seconds. At T + 3 minutes 15 seconds, the fire had propagated to the upper LH corner of the EL panel and had become quite intense. The test was terminated at T + 4 minutes 27 seconds. The silicone-laminate back cover was completely destroyed, and the wiring and circuit breakers were severely damaged. The Ladicote did not prevent the propagation of the fire. During the oxygen/nitrogen tests at 16.2 psia, fire propagation occurred at a slower rate. The test was terminated at T + 6 minutes 15 seconds.

Figure 41, - Post-test damage, face of panel 225 (test 306).

Figure 42. - Post-test damage, rear of panel 225 (test 306).

Corrective action — No satisfactory replacement materials or alternate systems have been found to replace critical components in the circuit-breaker panel; therefore, these results were instrumental in the decision to use a 60-percent-oxygen/40-percent-nitrogen launch atmosphere in the Apollo command module.

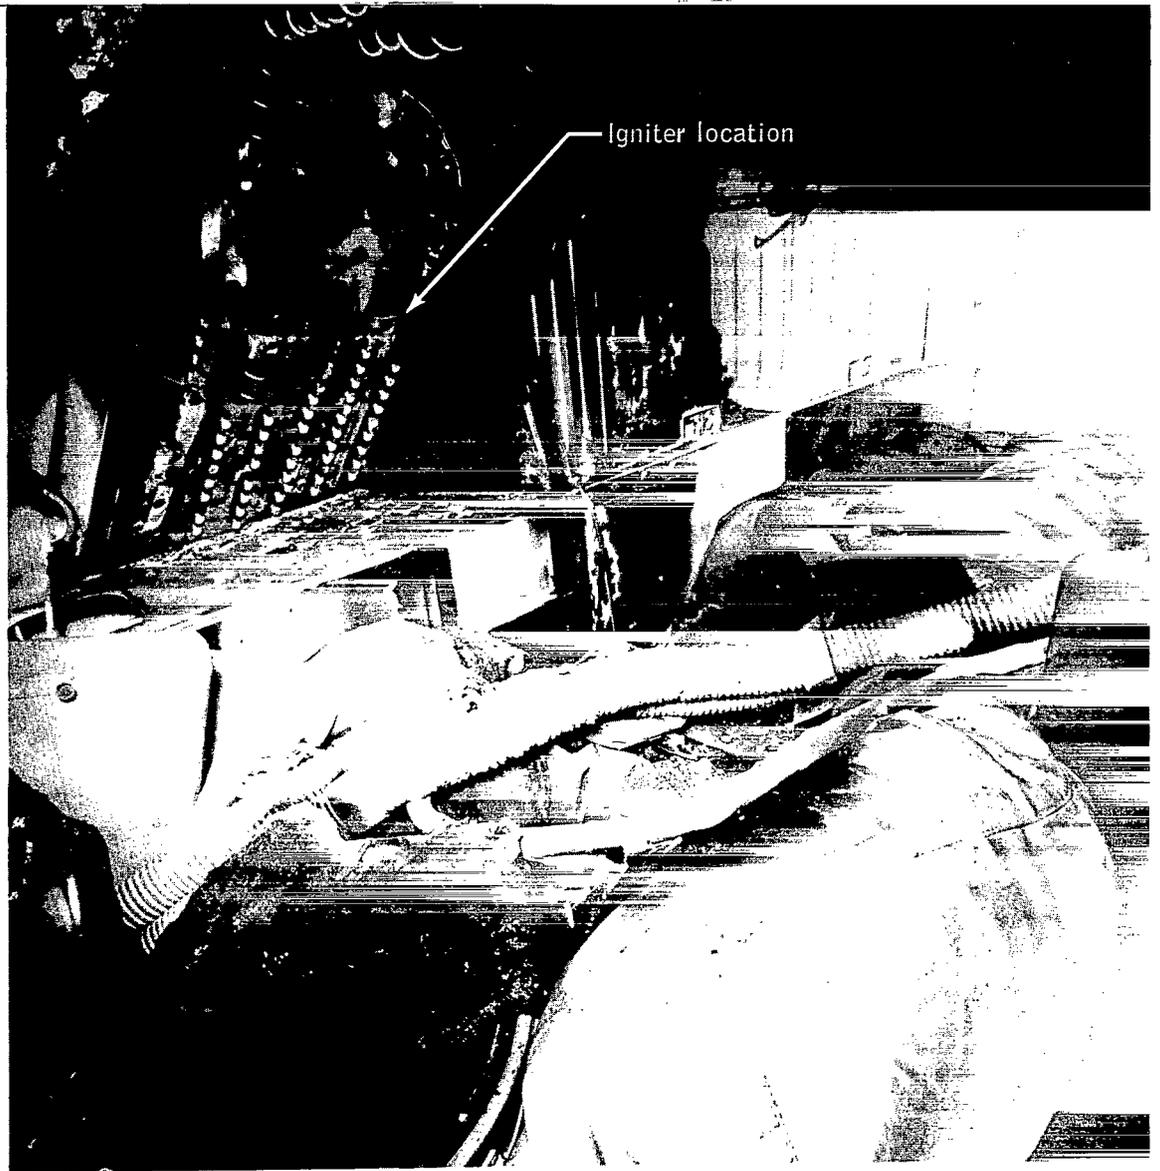
Figure 43. - Post-test damage (test 312).

Several tests of this series resulted in propagation to adjacent or remote ignition locations, and these areas were damaged or destroyed. The fire in test 312 (silicone-laminate cover on panel 8) damaged or destroyed the ignition locations for test 314 (saddle clamp adjacent to panel 8), test 305 (igniter on CB in panel 8), test 316 (saddle clamp in cabin heat-exchanger compartment), and test 340 (igniter in wire bundles leading to panel 8). Propagation resulting from test 312 was extensive and took place along the Teflon wrap on wire bundles leading to the heat-exchanger compartment, which had Fluorel sponge insulation. A severe fire resulted in that region and damaged wire bundles, rendered the cabin fans inoperative, and melted aluminum panels surrounding the heat-exchanger compartment. Molten aluminum and flaming particles dripped from this region onto the suit on the LH couch and caused ignition of the suit and a considerably intensified fire.

Three tests in this series resulted in ignition of a suit, of one or more pairs of oxygen hoses, and of one or more cobra cables. Test 312, previously described, resulted in extensive damage to the left arm, torso, and helmet of the suit. The fire in test 303 (ignition of a switch in panel 2) propagated to two pairs of oxygen hoses. The suit was also ignited during this test, either because of the dripping of flaming particles from panel 2 or because of propagation along the oxygen hoses to the suit. The Dacron restraint-harness straps burned rapidly and provided a propagation path across the suit chest and over the left shoulder of the suit to the underside of the center couch. Test 341 (connector under silicone-laminate cover on cabin floodlight on RH couch aft strut) resulted in ignition of one pair of oxygen hoses and, subsequently, in ignition of the right foot of the suit on the center couch. The fire burned through the pressure garment assembly and destroyed the pressure integrity of the suit. The left foot of the suit on the RH couch also incurred damage during the test.

Silicone-laminate cover (16.2 psia 100 percent oxygen). - The igniter was placed on the edge of a silicone-laminate cover. Within 1 minute after ignition, visible flames were observed, and there was a rapid buildup of smoke in the crew compartment. The fire propagated to the heat-exchanger area, and dripping particles were observed coming from that area. At T + 2 minutes 50 seconds, the space suit ignited, and the fire propagated rapidly to the helmet region of the suit. The test was terminated at T + 2 minutes 57 seconds. A number of switches and several circuit breakers on the front of the panel were severely damaged. There was extensive damage in the area of

Corrective action — These test results prompted replacement of the material used in the silicone-laminate cover. These results also were instrumental in the decision to use a 60-percent-oxygen/40-percent-nitrogen launch atmosphere in the Apollo command module.

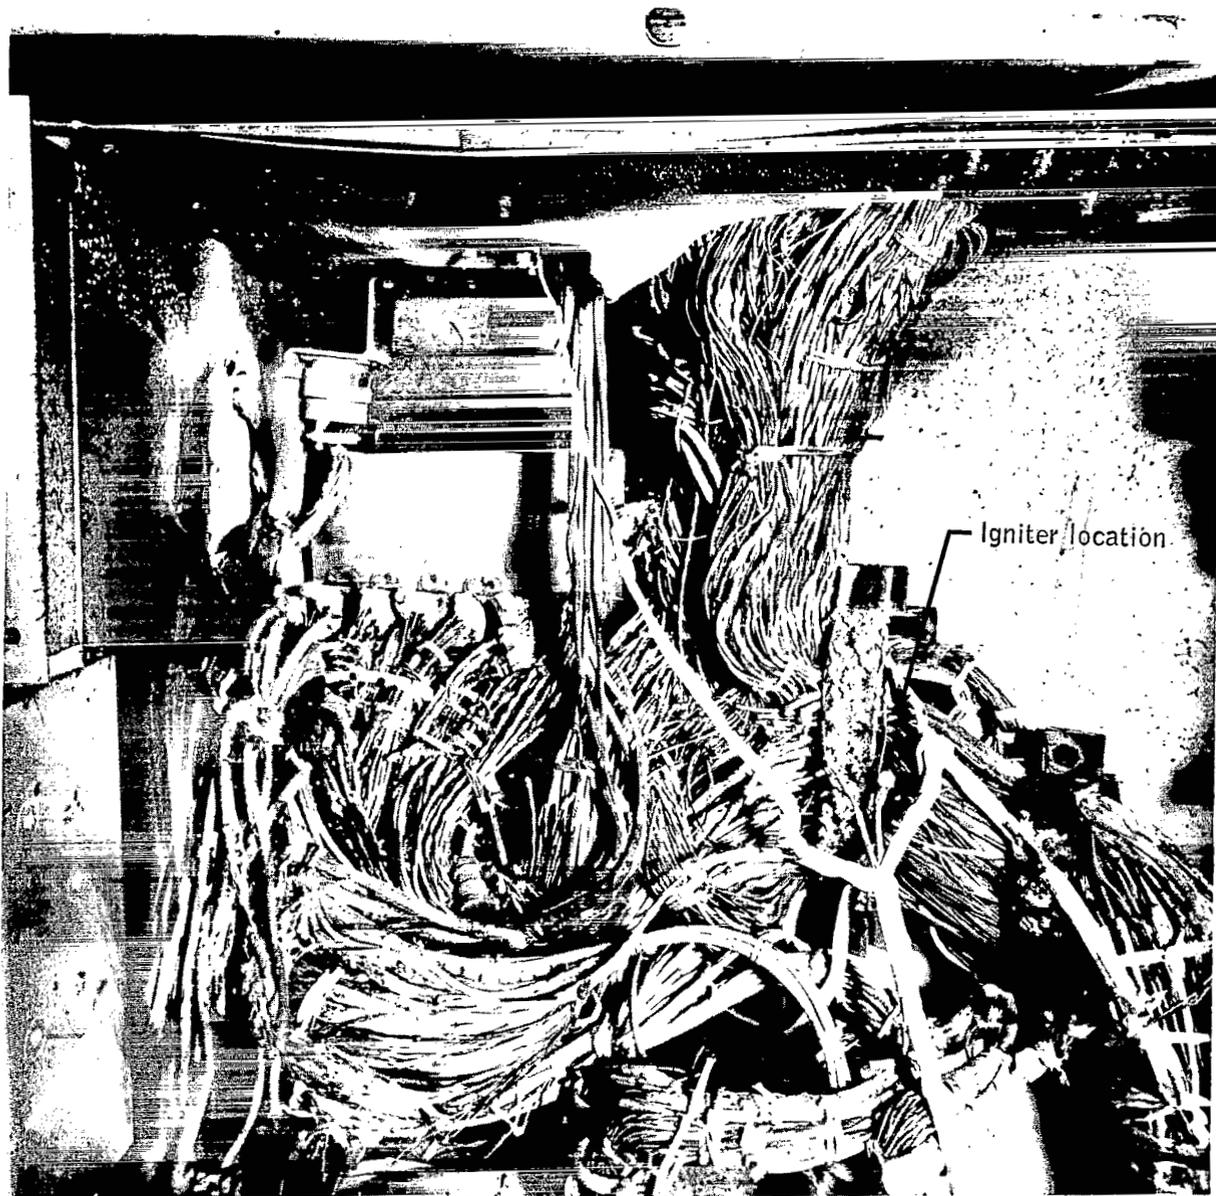
In test 319 (igniter adjacent to coaxial cable in the lower equipment bay (LEB)), significant quantities of coaxial cable in the test region burned, and a large fire resulted which destroyed the Teflon insulation on approximately 75 percent of the wires in this region. Propagation took place along the coaxial cable to the region above the girth shelf where the coaxial cables are wrapped individually with aluminum tape to provide fire protection. The aluminum tape was ineffective in preventing propagation in this atmosphere, and the fire proceeded up the vertical bundle of coaxial cable until the test was terminated.

Figure 45. - Post-test damage above girth shelf (test 319).

Figure 46. - Post-test damage below girth shelf (test 319).
